Debris/Ice/TPS Assessment And Photographic Analysis For Shuttle Mission STS-31R

Charles G. Stevenson
NASA/Kennedy Space Center

DEBRIS/ICE/TPS ASSESSMENT
AND
PHOTOGRAPHIC ANALYSIS
OF
SHUTTLE MISSION STS-31R

April 24, 1990

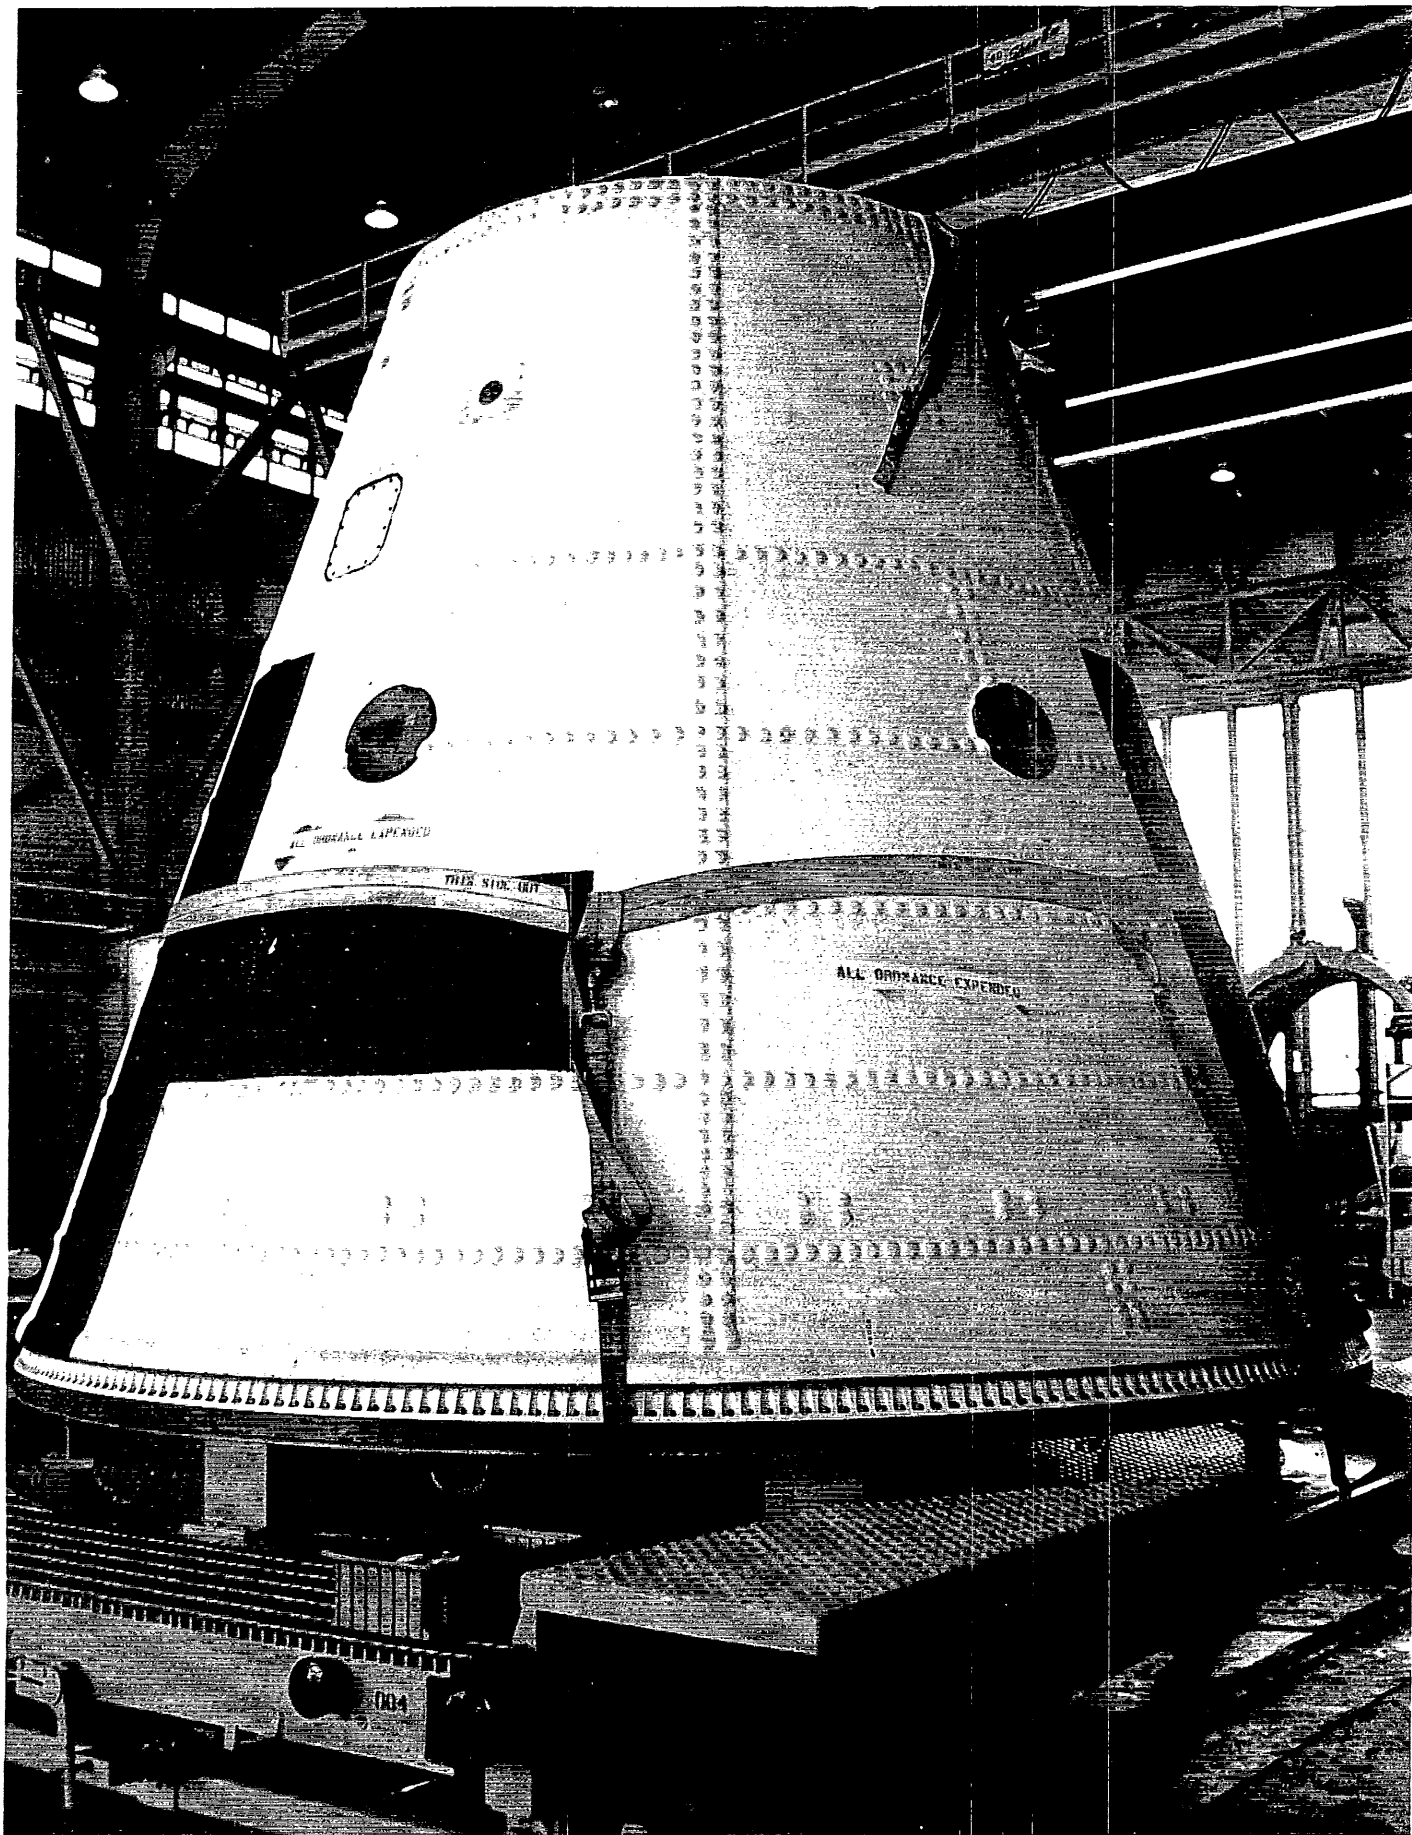
Post flight condition of RH frustum. There were 5 debonds over fasteners, but no areas of missing TPS.

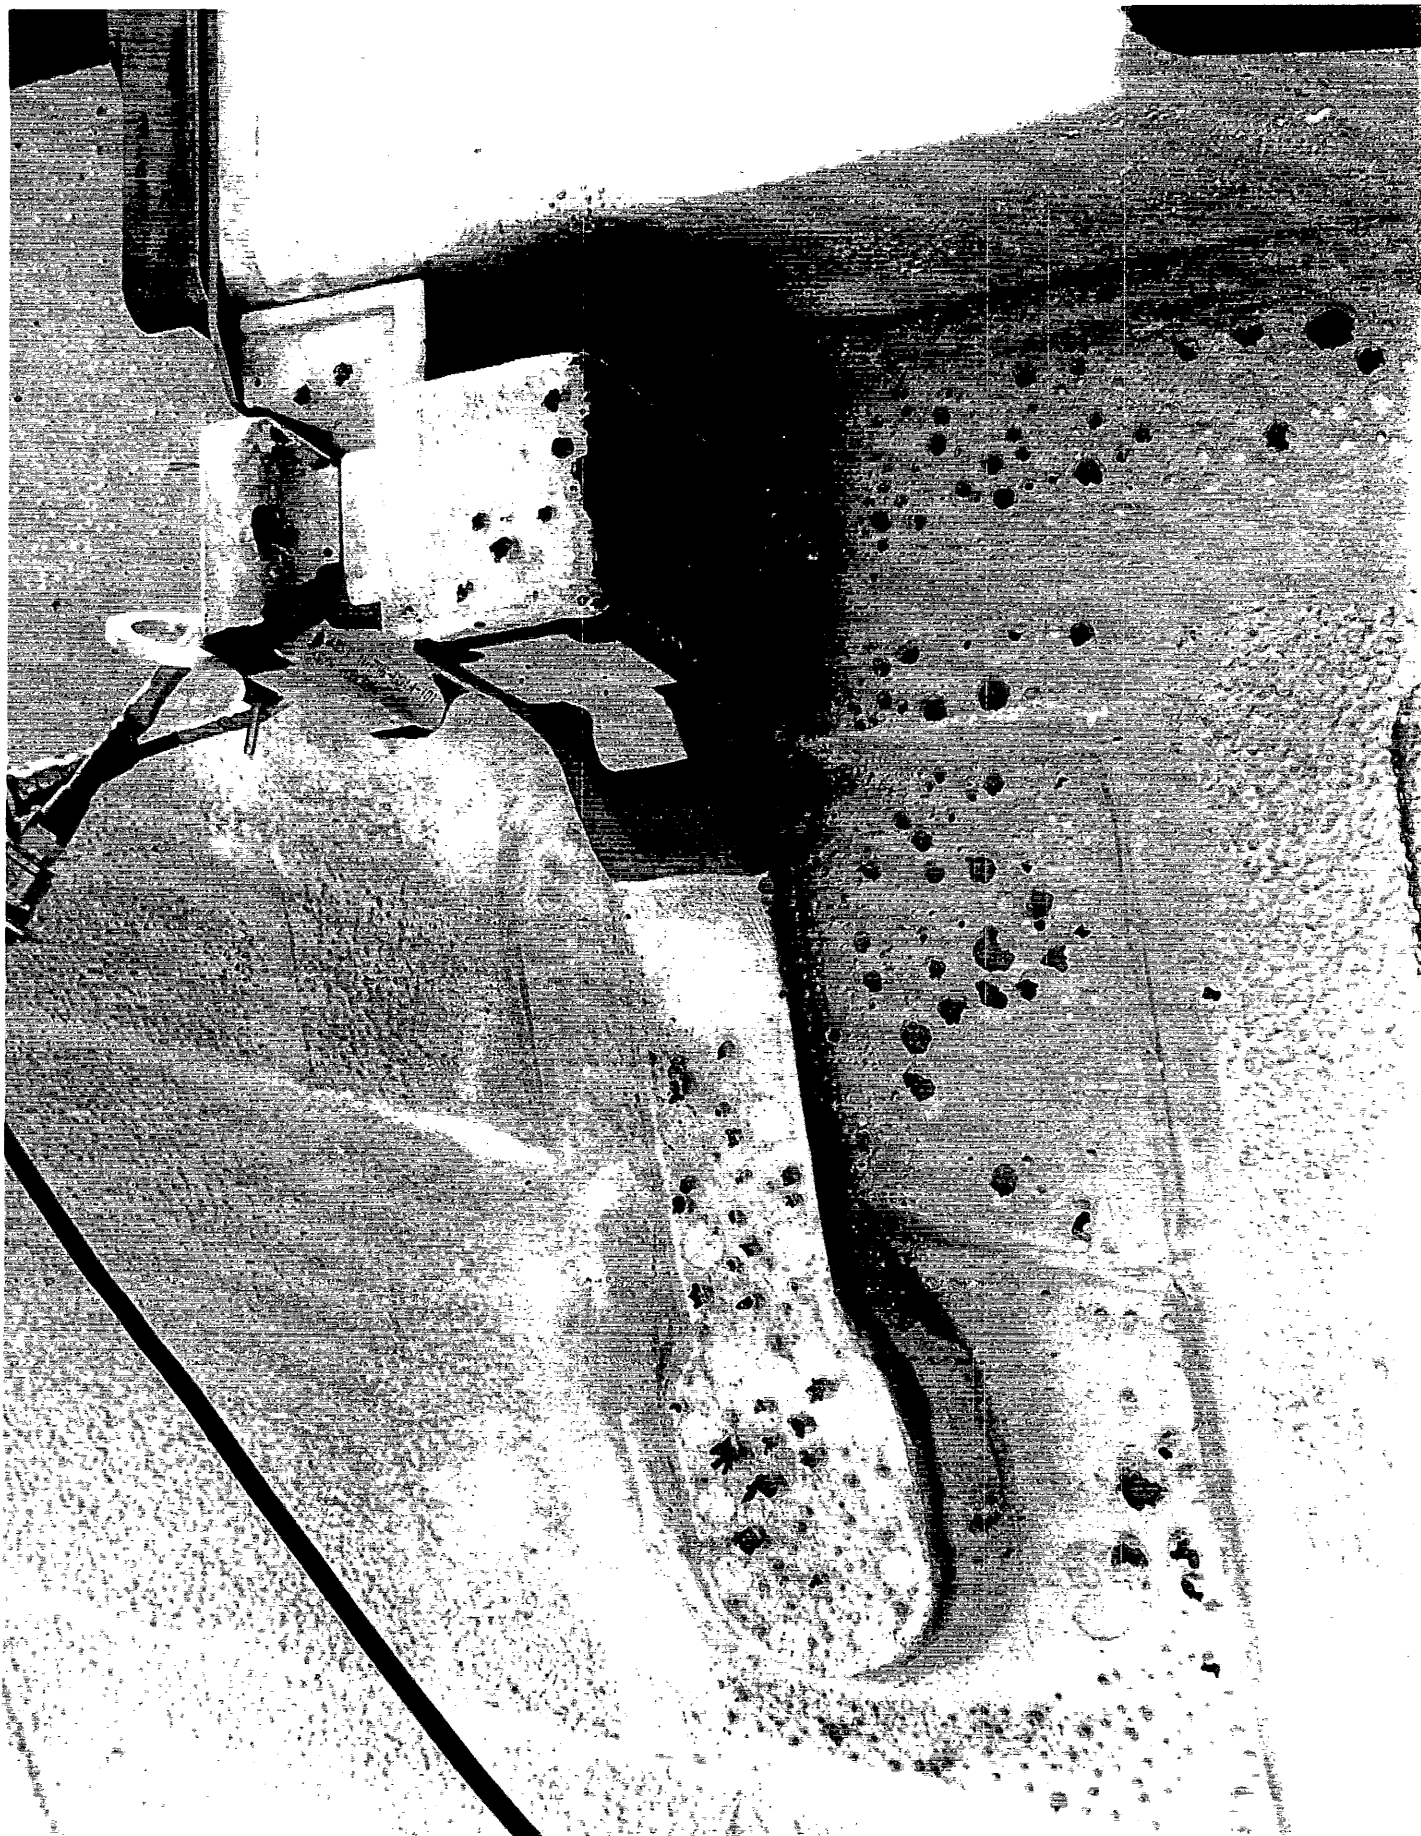
Localized areas of Hypalon paint blistered with some layers of
MSA-2 adhering to the paint

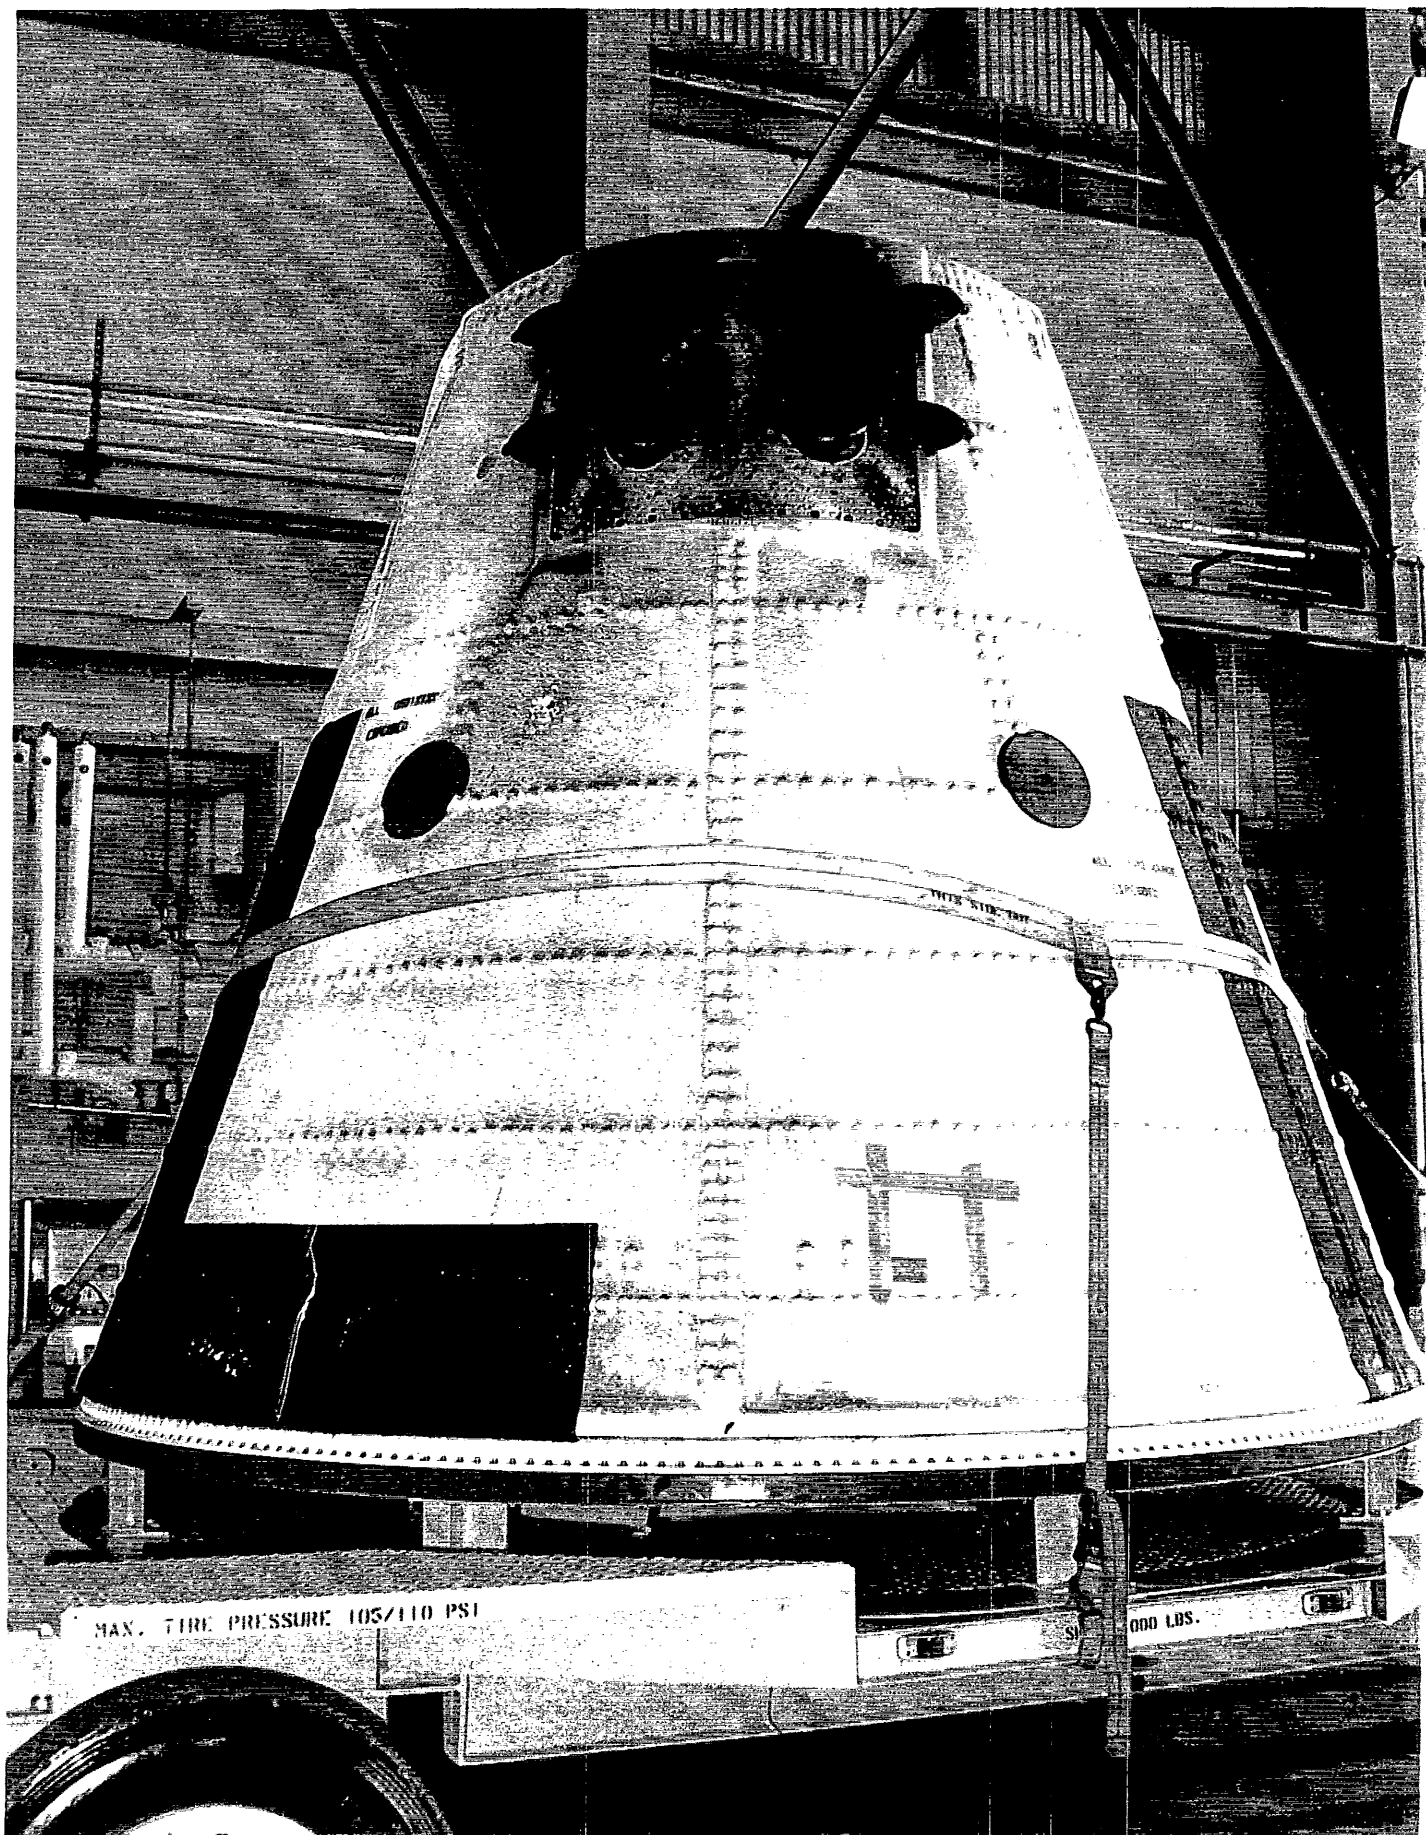
Post flight condition of the LH frustum. There were 7 debonds over fasteners, but no areas of missing TPS.

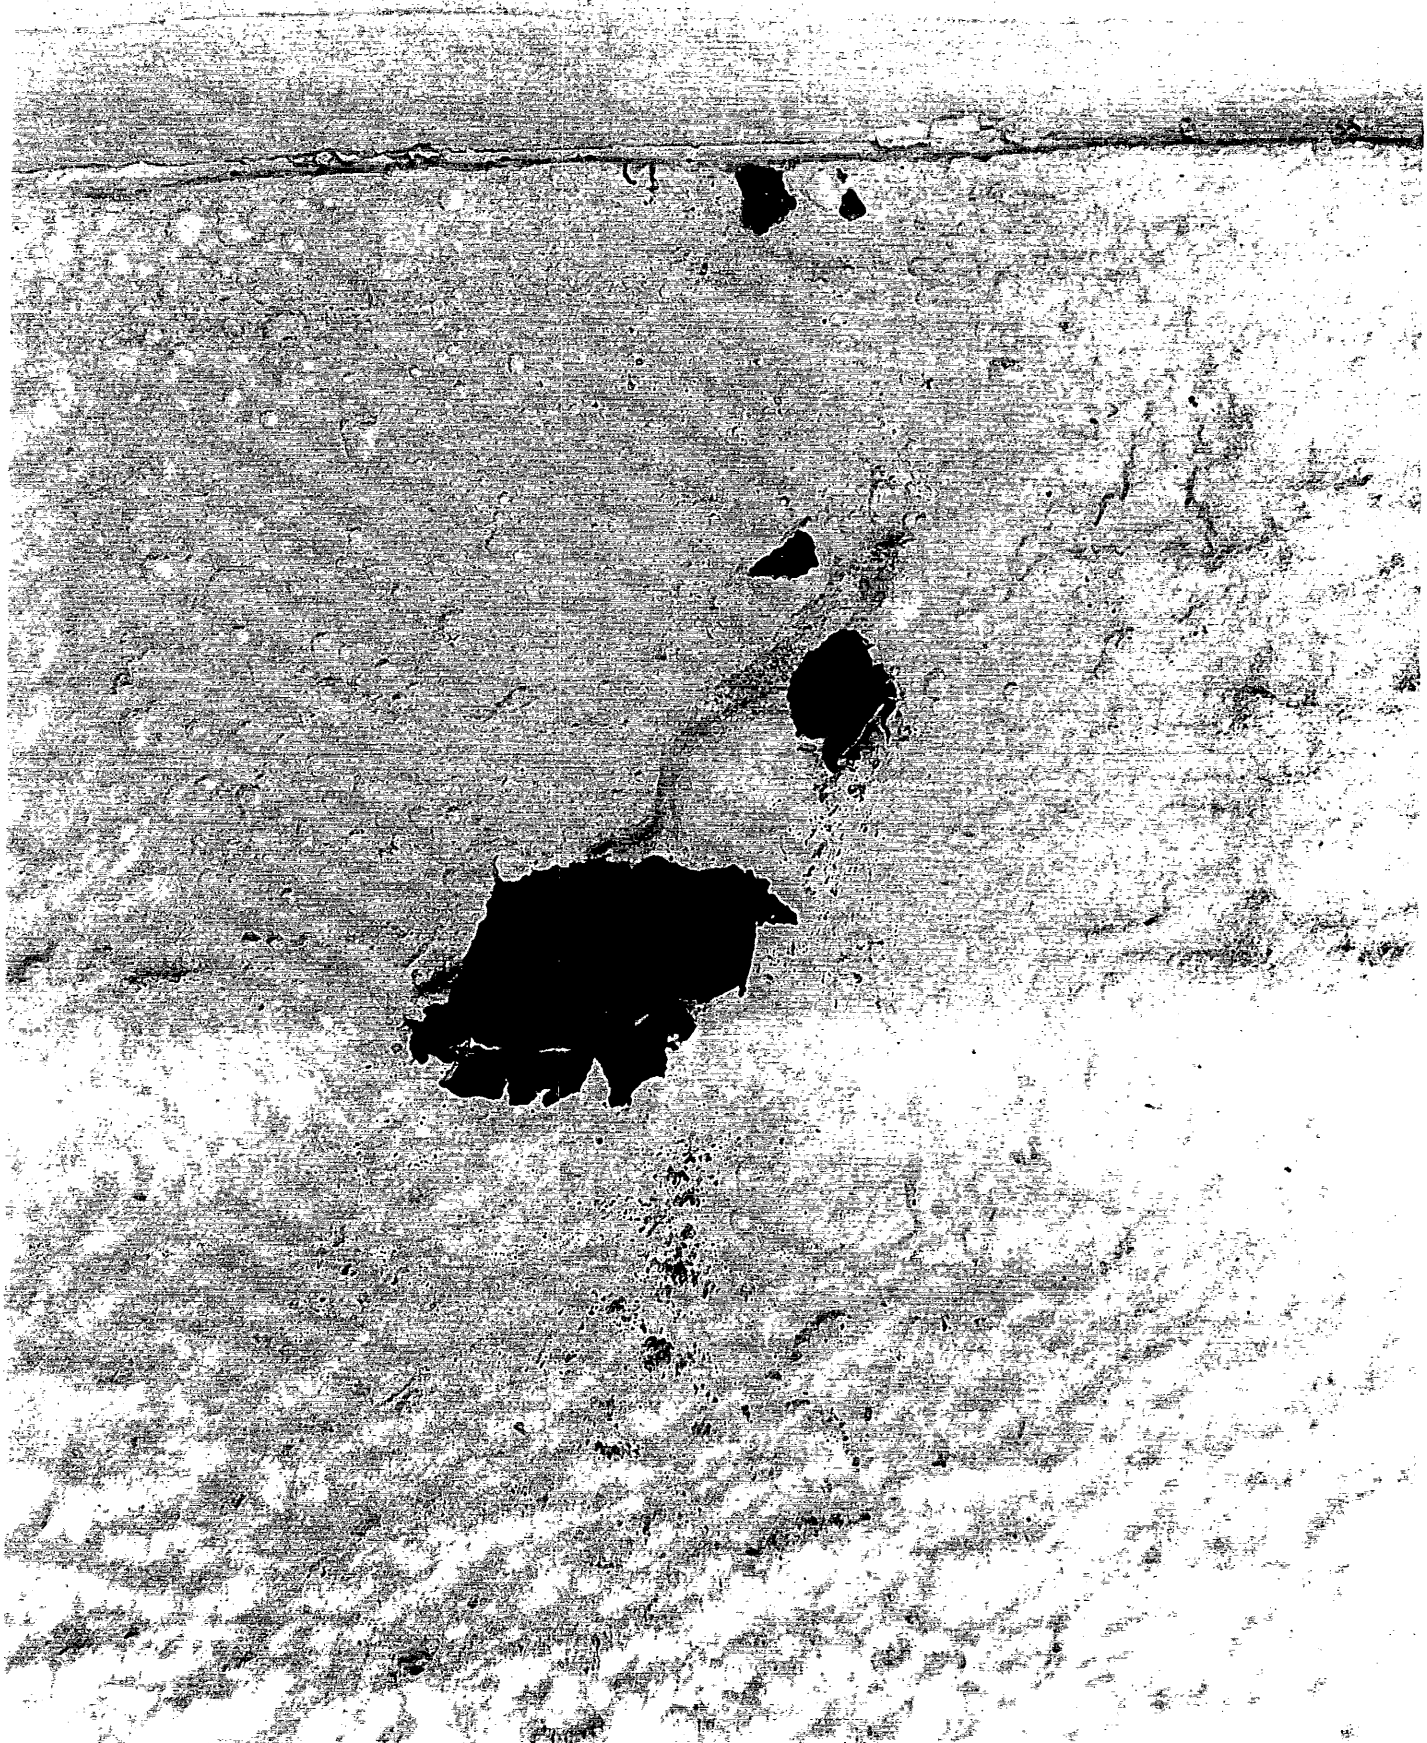
Layers of MSA-2 adhering to Hypalon paint blisters increases
the mass of the paint chips and causes tile damage

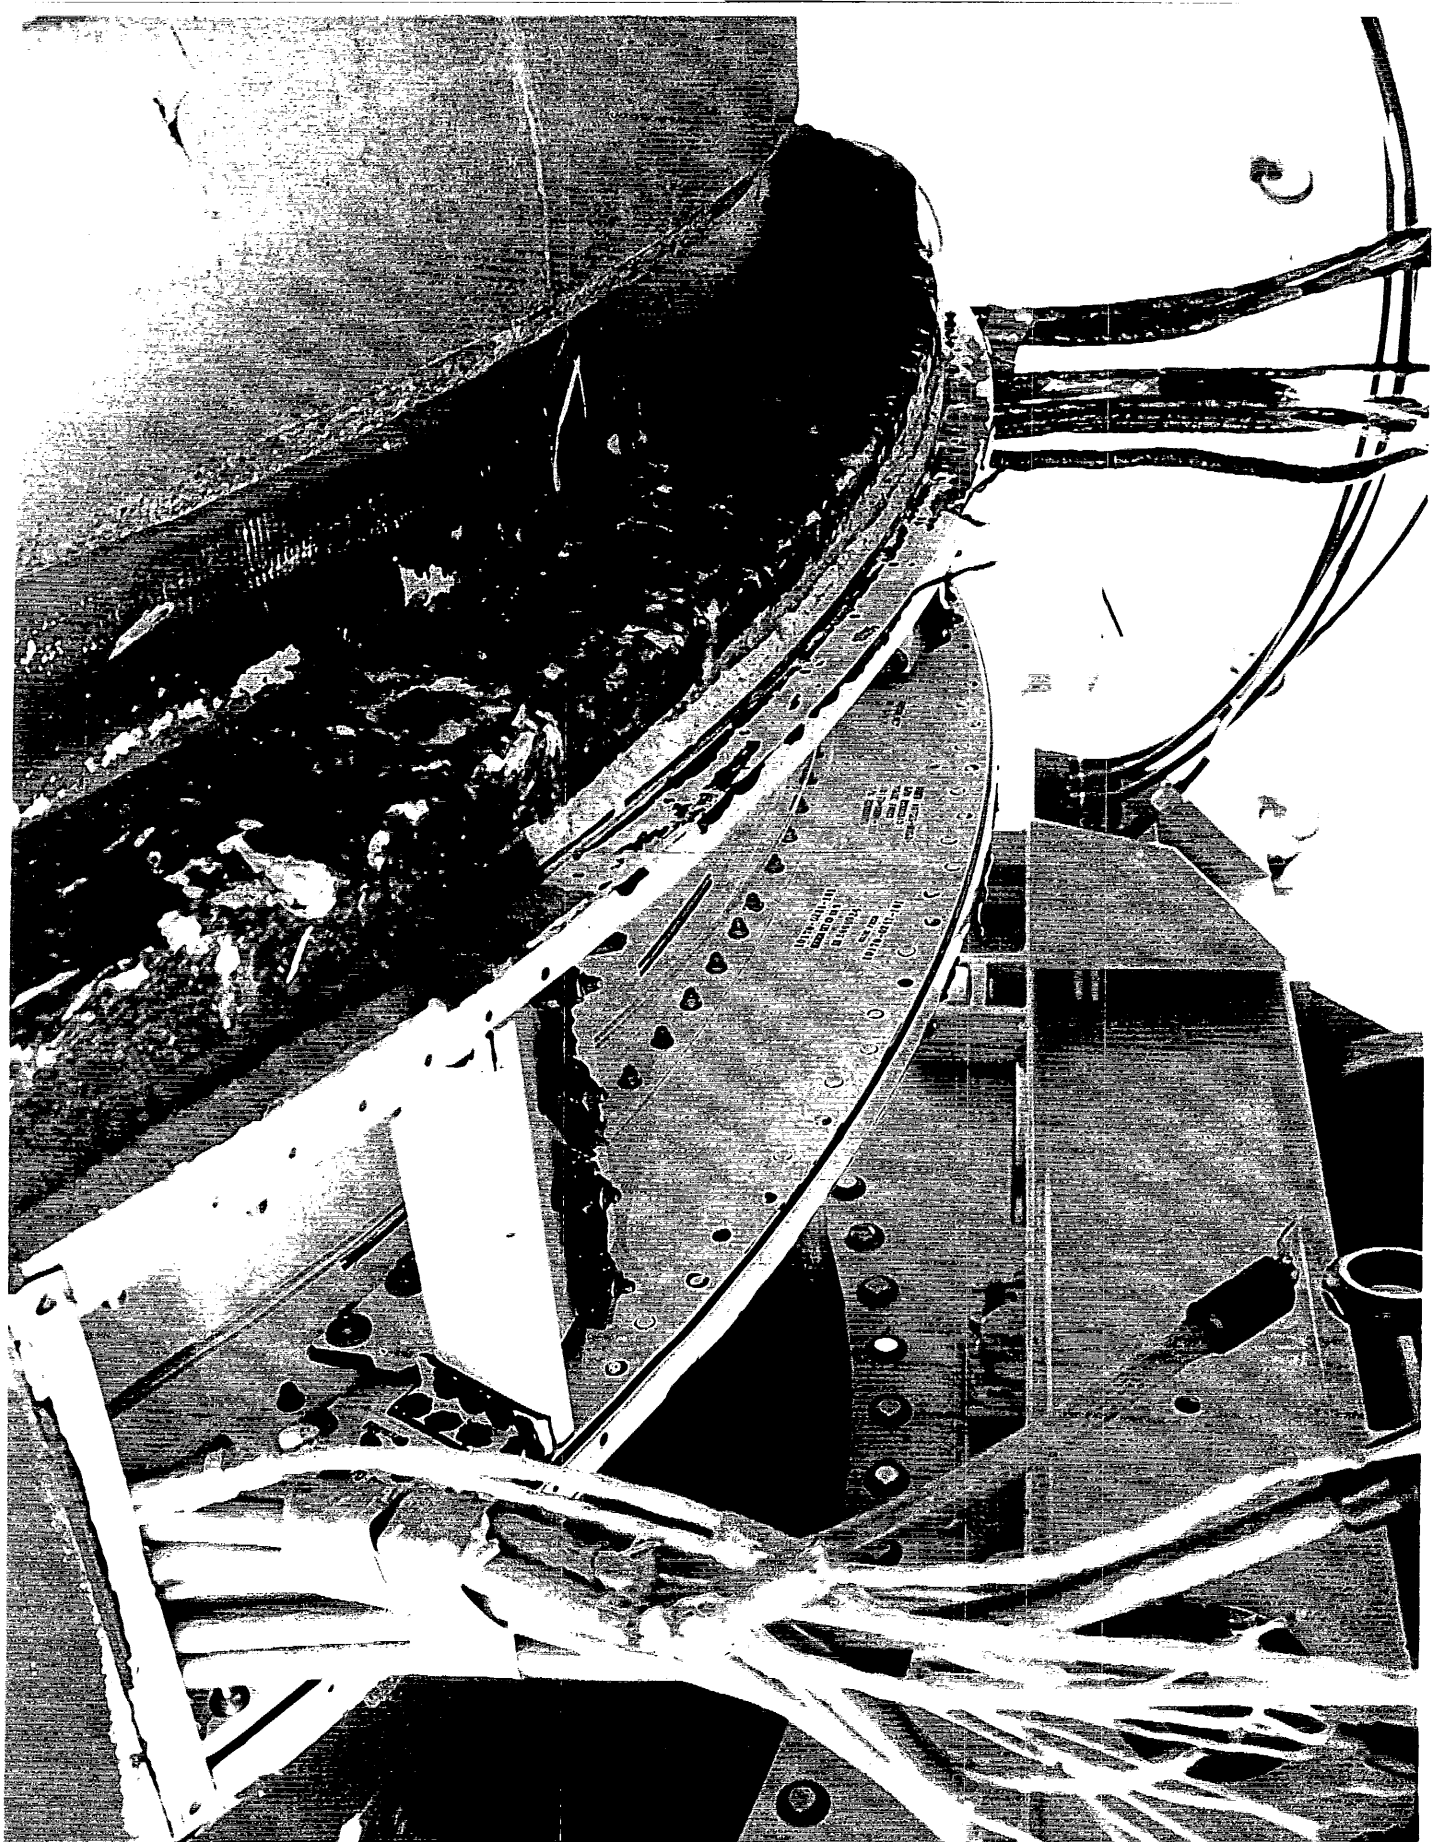
Loss of the LH IEA from the ETA ring at water impact was not attributed to any debris issues

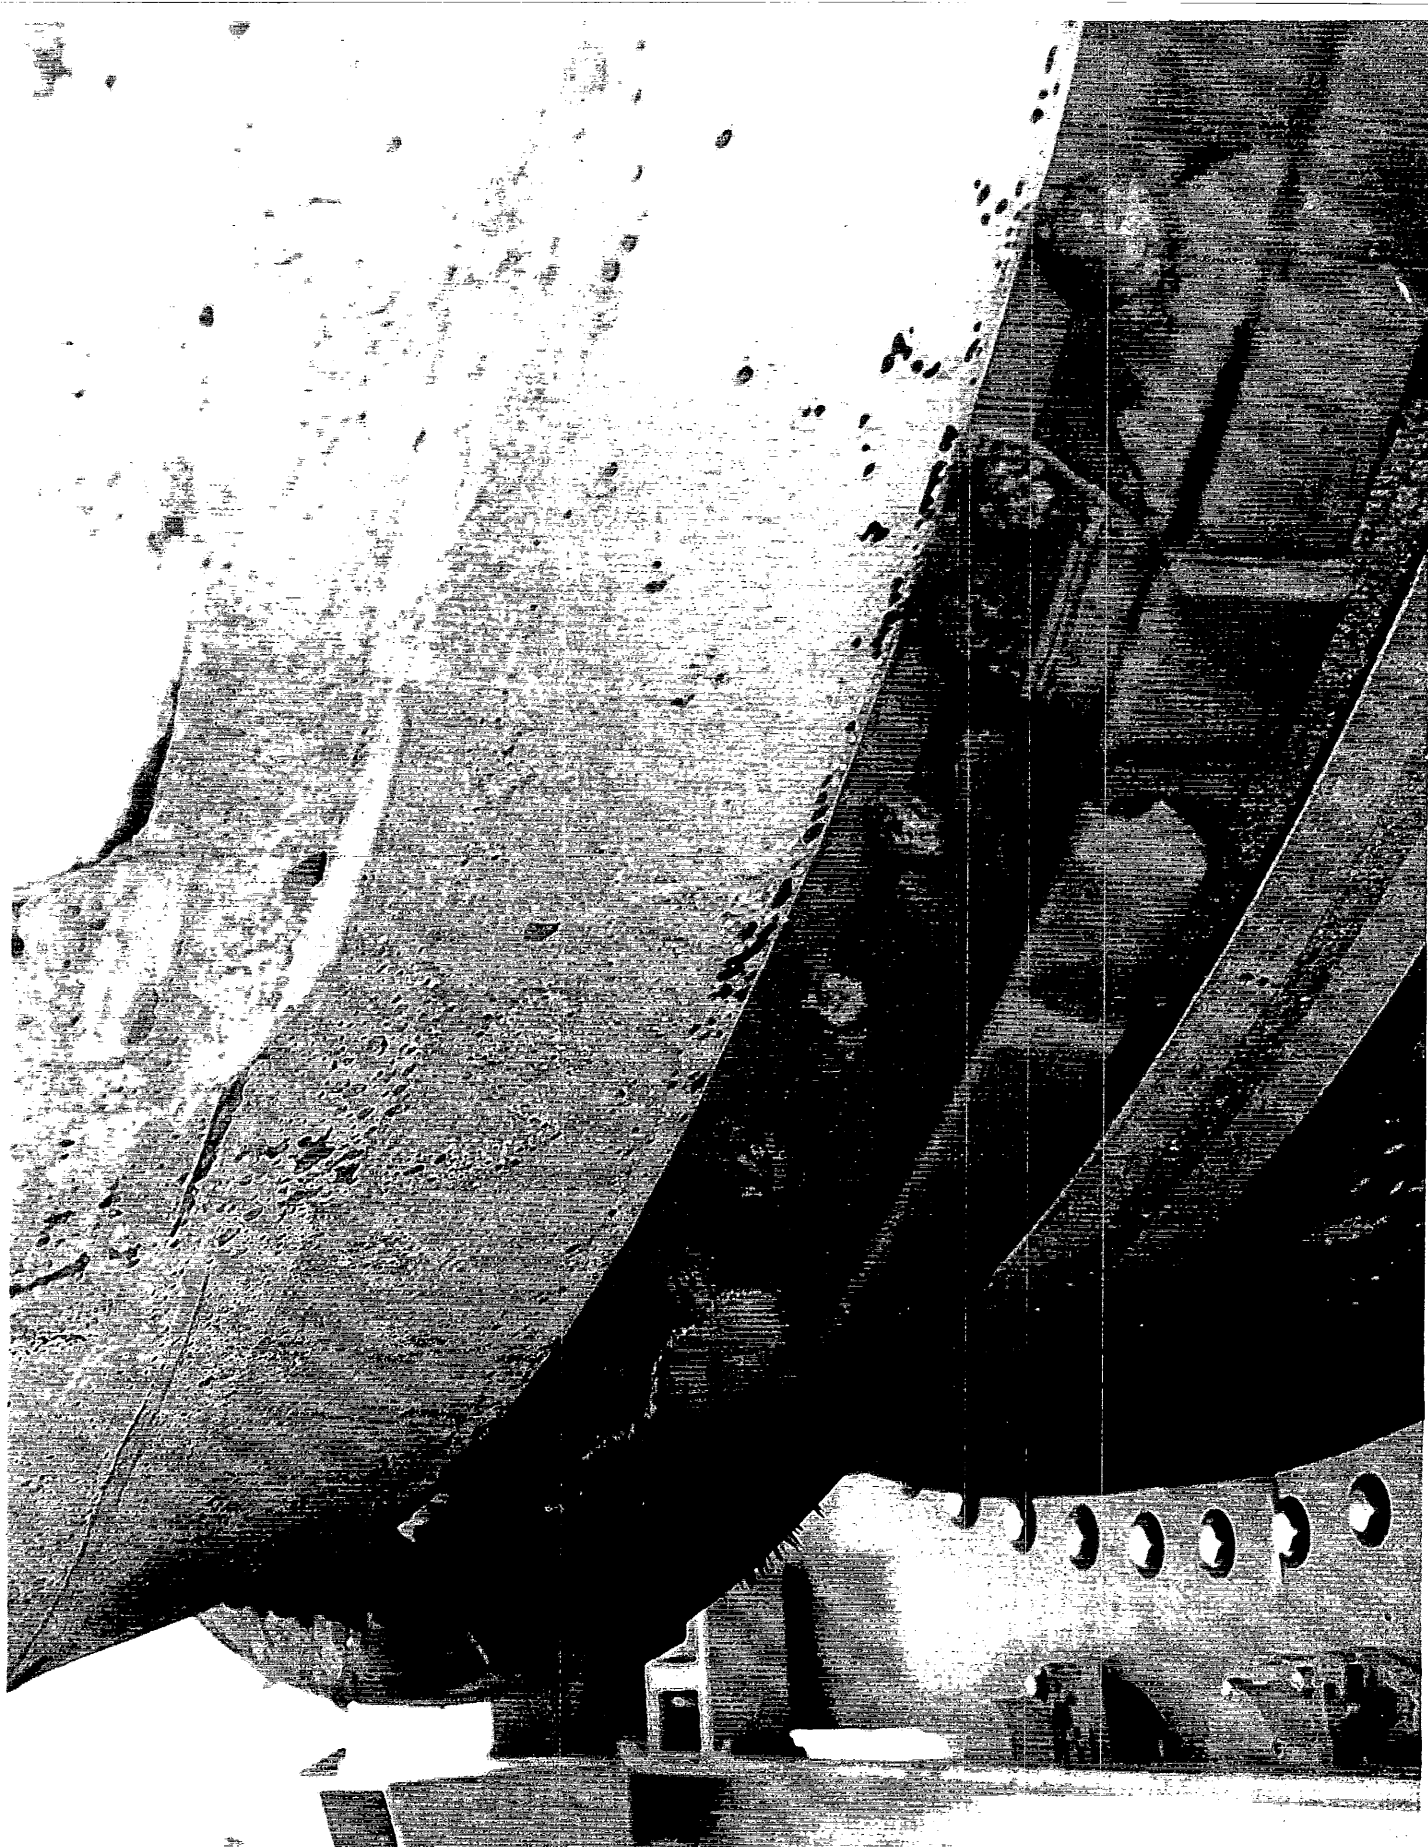
Phenolic material on the kick ring delaminated at several locations. K5NA protective domes were missing from boltheads.

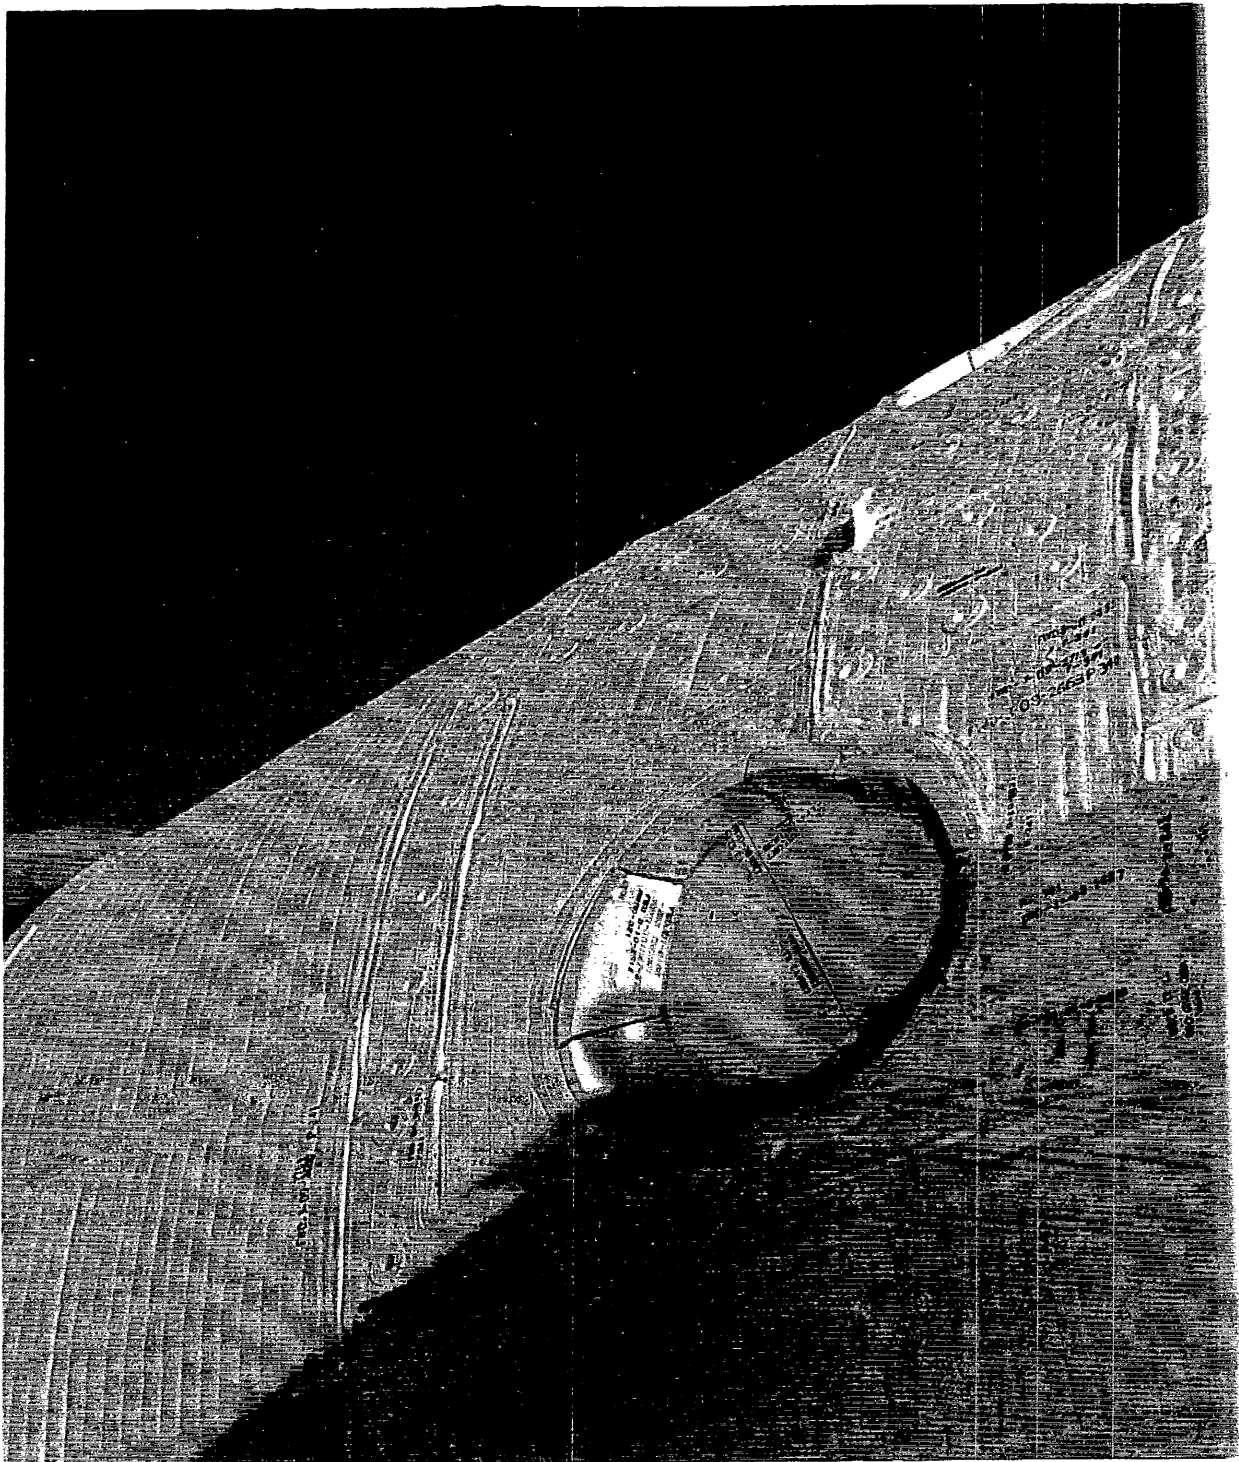
A 3"x3" tile corner was broken and loosely attached in the
Y star tracker cavity

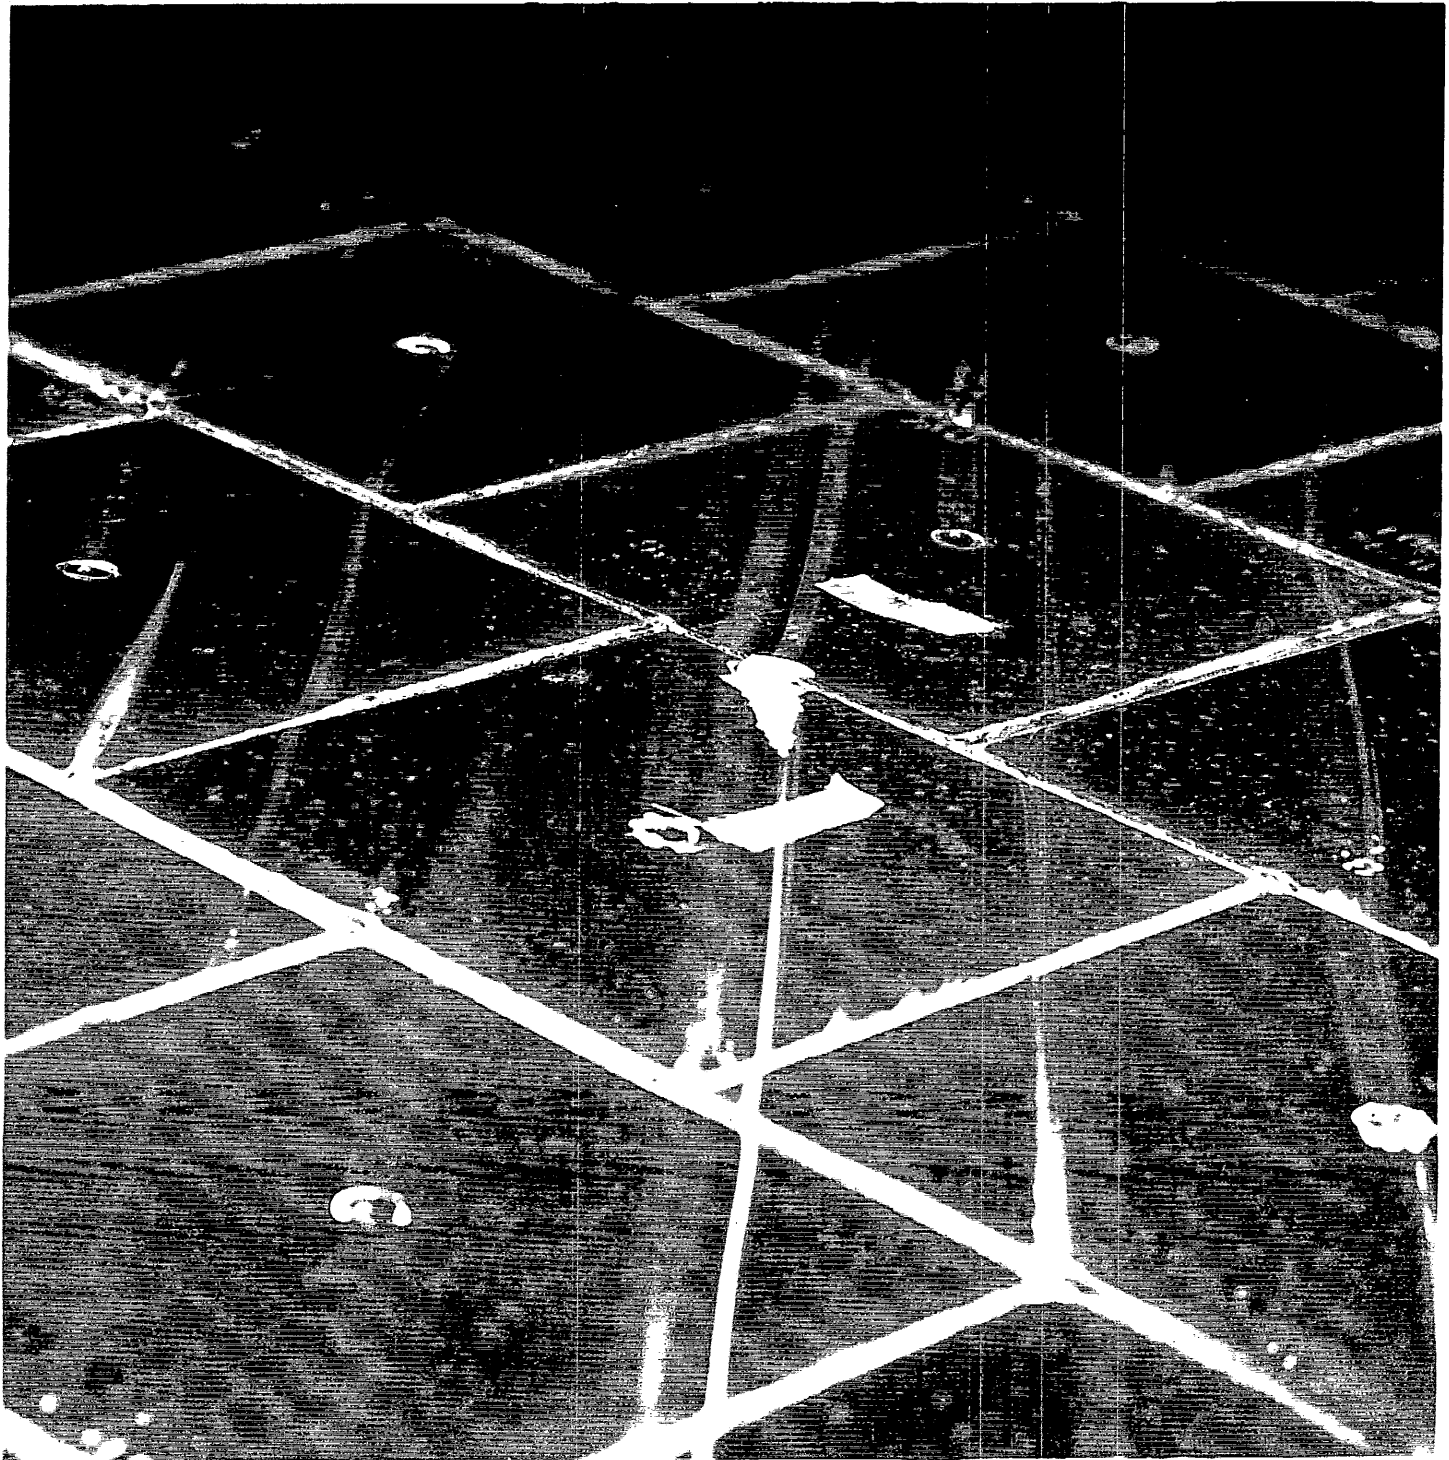
Typical debris impact damage to lower surface tile

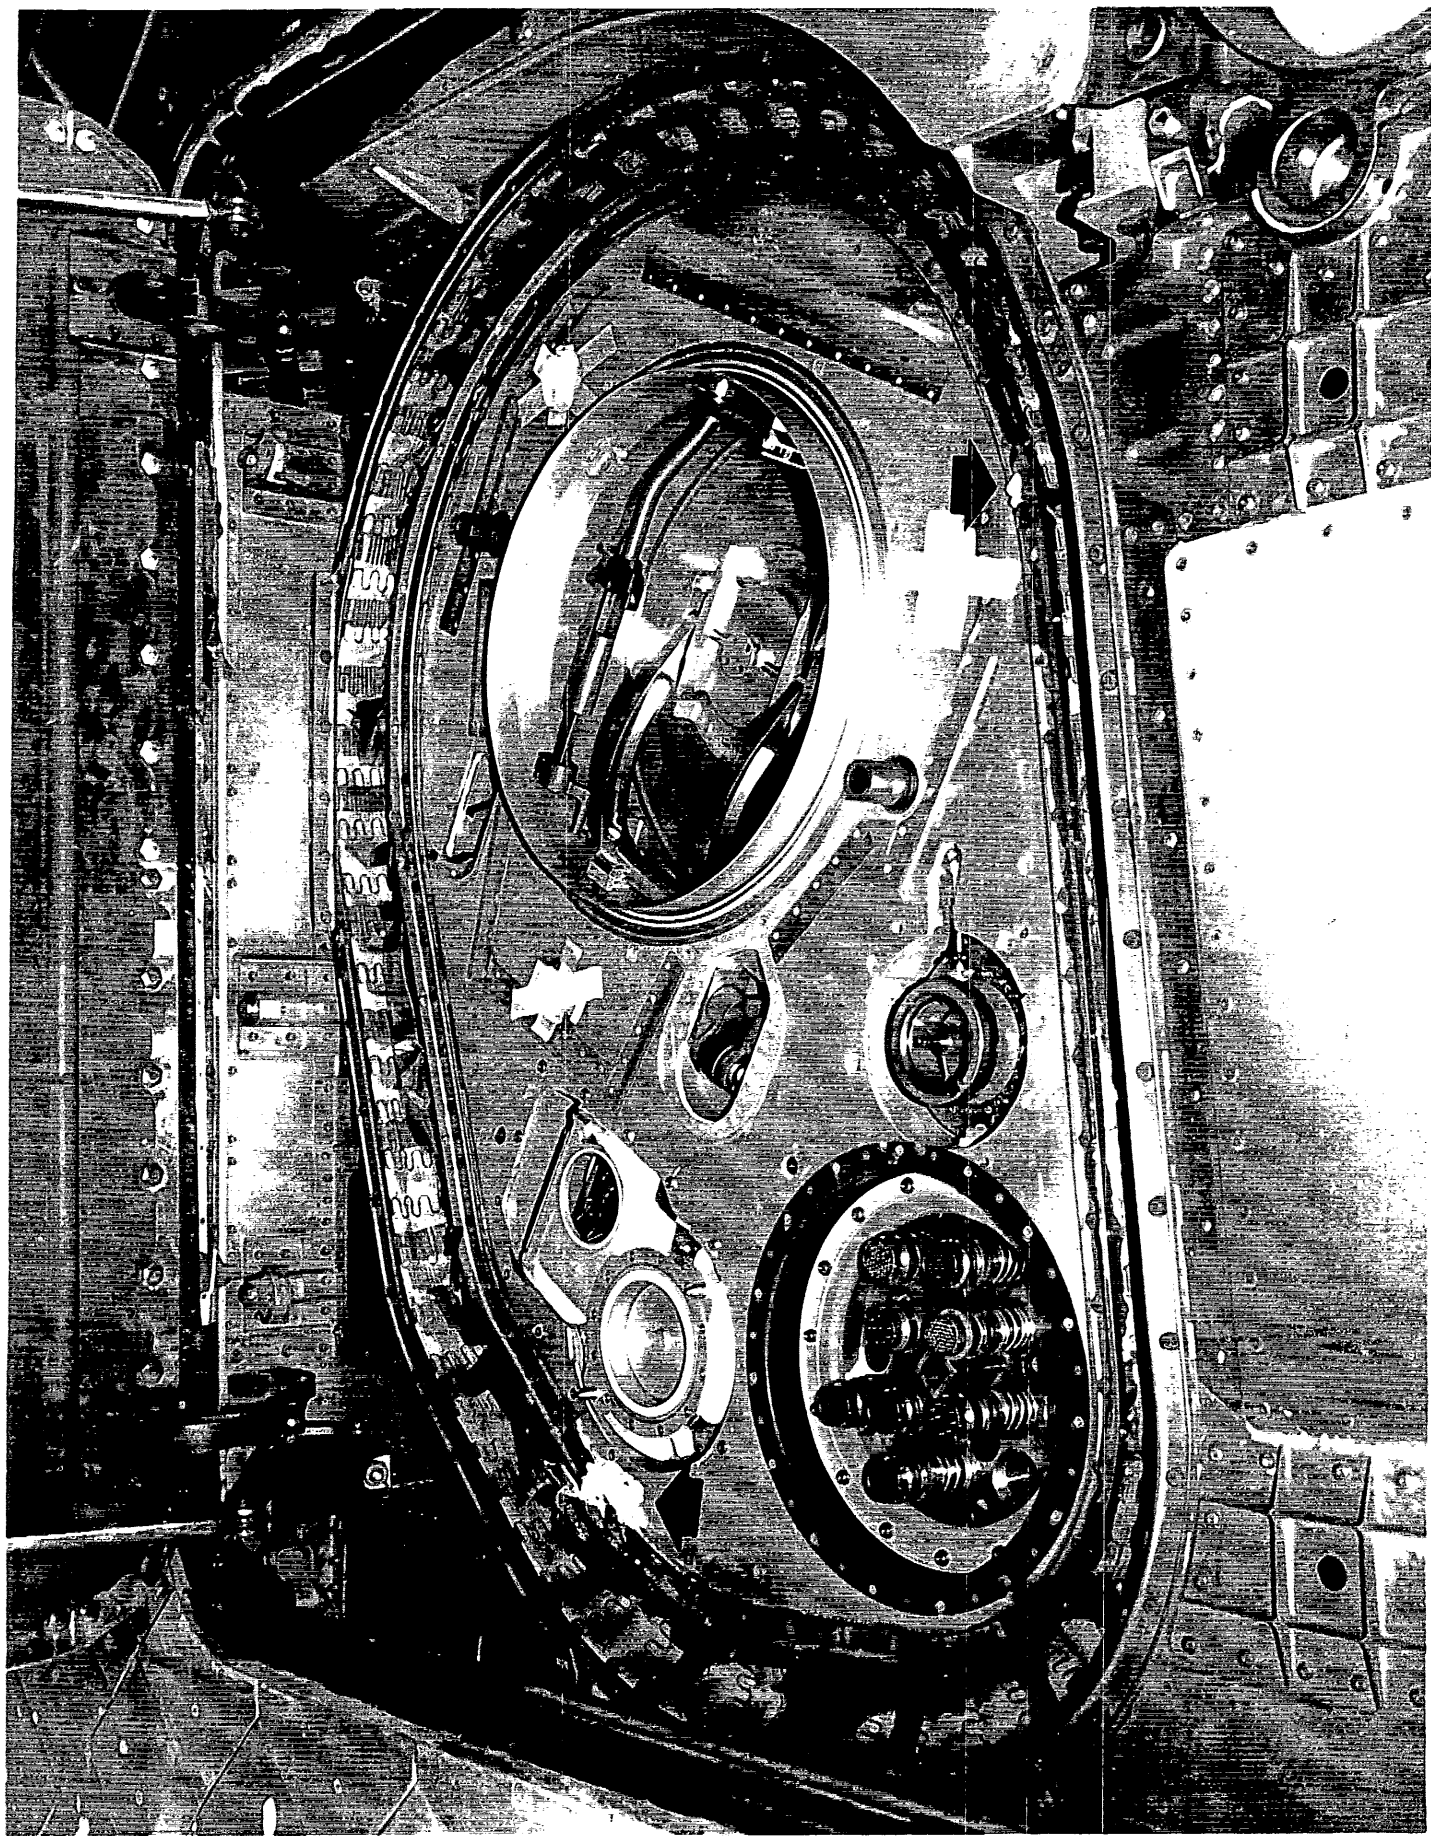
Post flight condition of the LH2 ET/ORB umbilical. Note closeout foam intrusion along interface (arrows)
